The Performing Arts Center

Turner

Technical Assignment 2: Production Analysis

Eric Luttmann | Construction Management | <http://ewl5165.weebly.com>

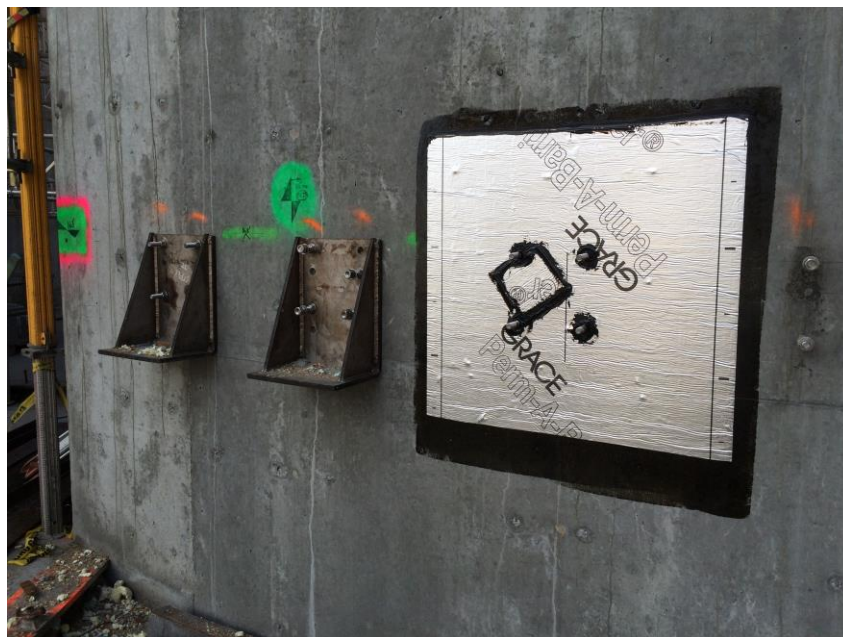
Figure 1: Bracket-anchor system to support Lecce Limestone Panels & waterproofing barrier on DRUM Façade

The exterior stone cladding system is composed of Lecce Limestone Panels that vary from 2’0” high by 3’0” wide to 3’0” high by 5’0” wide. The panels are 3” thick and are supported by stainless steel anchors which transfer the dead load to the cast-in-place concrete wall and integrated steel structural system. Plug anchors secure the stone to the steel bracket channels in the concrete wall to resist wind and lateral loads. Supporting brackets were installed to test labor efficiency. The project includes 500 brackets with 4 holes that anchor the bracket to the concrete wall. In 1 day, 10 of them were installed in 8 hours. This meant the steel installer drilled 40 holes, installed 40 anchors and hung 10 brackets. At 500 brackets, performing 10 a day means that it will take 50 days of work to drill holes. To install these brackets, workers will be supported by knee-brace scaffolding that is raised by a crane and sits along the wall at a certain height.

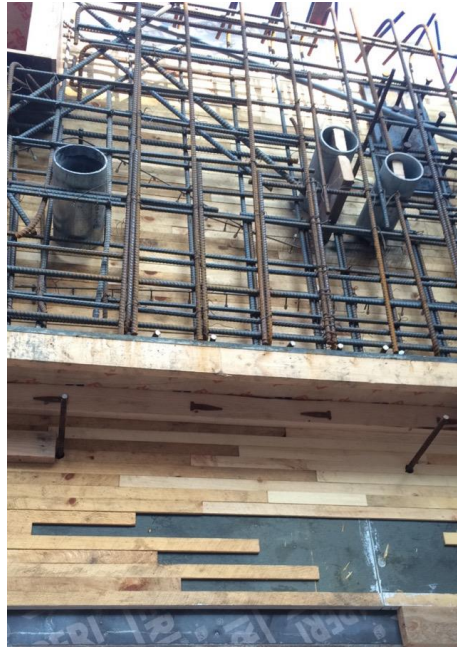
Figure 4: Pre-fabricated wooden Board form placed inside steel concrete form with rebar being set.

Concrete is placed on the façade walls 3-4 times a week with 100 – 300 cubic yard poured per day. This equates to 13 trucks a day, necessary to pour façade walls based on a standard 10 cubic yard concrete truck. When pouring concrete, a very unique solution is used as a means of maximizing length of each pour. On a straight run, the entire form will be raised along the length of the wall. The board form is placed inside, along with rebar. Then, the other wall is flown in pieces and stood up next to the wall. To make this work, the wall needs to be slid with the crane and inched over until it fits snug. See figure 4 to see the inside of a form before the second wall is slid into place. In many areas, there will be dowel bar notches in the concrete wall so that re-bar can be screwed in later. In order for this happen, cup-shape metal pieces are attached to the formwork to leave a gap for the re-bar. This is especially effective when it is necessary to add re-bar to an existing wall that will tie into another wall.

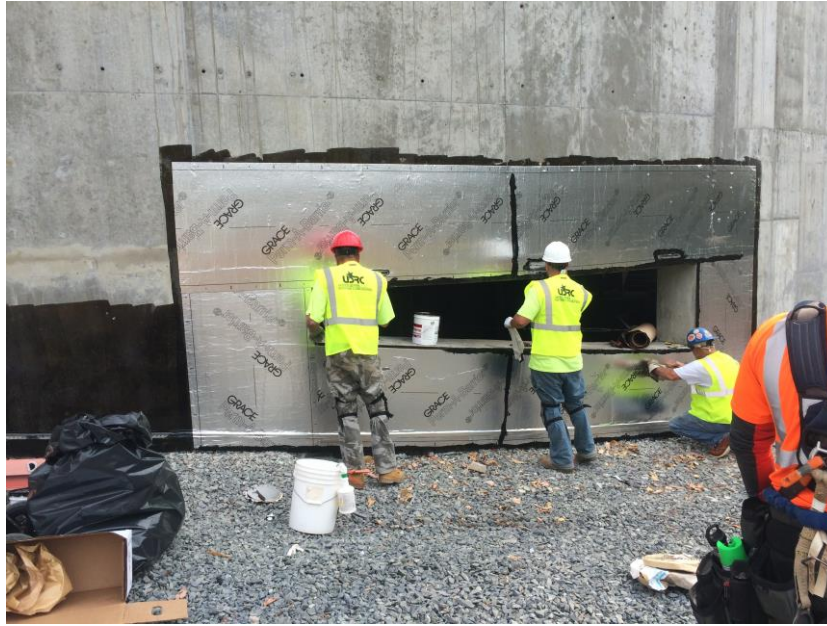
Figure 6: Installation of glazed curtain wall system on north DRUM Façade

Installing the glazing and curtain wall systems is no easy task on the Performing Arts Center. Due to complex and irregular geometric forms, connections need to be engineered and installed with great detail. For instance, on the DRUM's north façade, the first portion of glazed curtain wall system was being installed with extreme attention to detail so that connections followed up the radial curve of the DRUM and so that the steel paneling would integrate successfully with the steel structure. It took at least 4 hours for glazing subcontractors and surveyors to lay out and field verify connection levels and angles so that the strip of curtain wall would fit correctly. Next, they would install the stainless steel brackets that have been cut out of the waterproofing lining. Anchors will be secured to the base structure and attached to the glazing system. A crane will pick up panels and then crews will secure the steel structure of the glazing to the anchors.

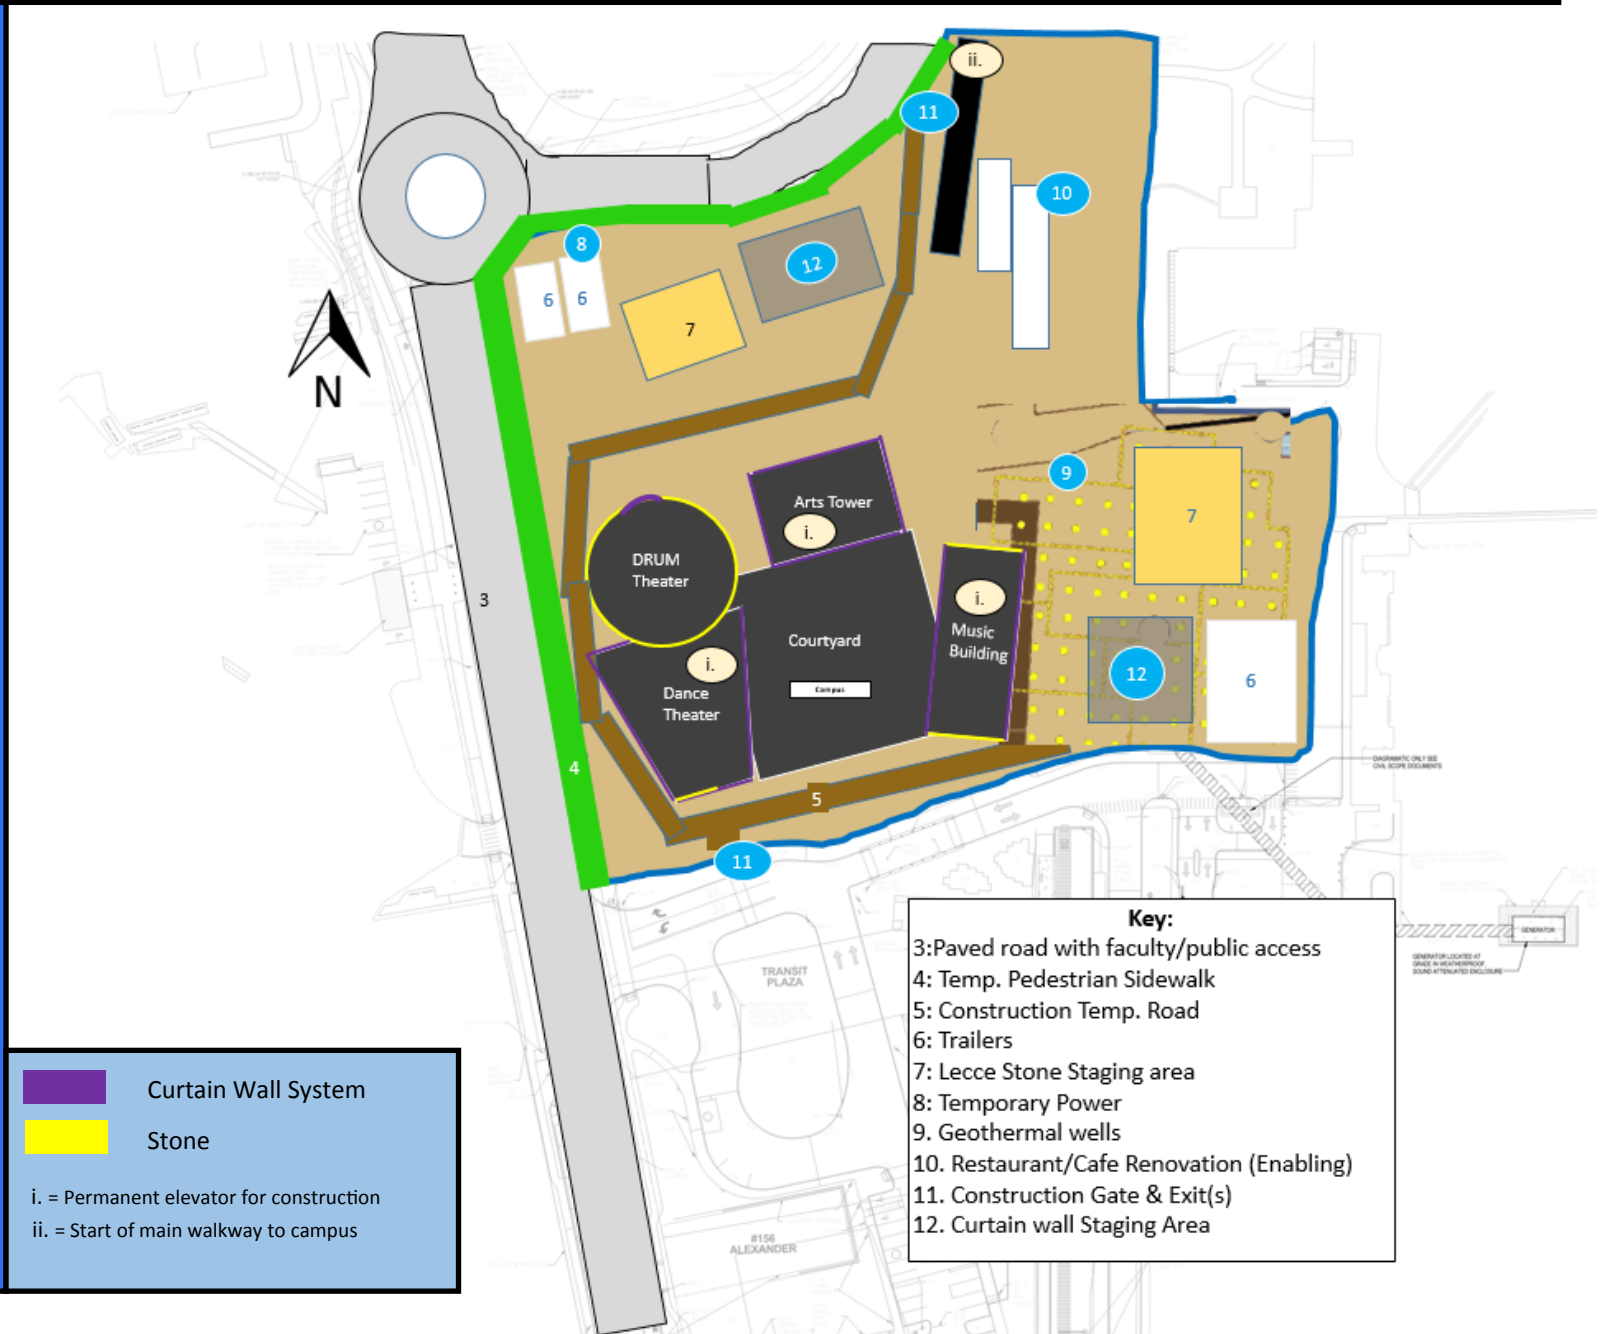
Façade Logistics Design –Phase 3

- Building Enclosed
- Curtain Wall Framing Complete
- Skylight and glazing complete
- Lecce Limestone—80% Complete
